No. 753

MEASUREMENT OF THE FORCES ACTING ON GLIDERS IN TOWED FLIGHT

By W. B. Klemperer
The Soaring Society of America, Inc.

Washington
February 1940

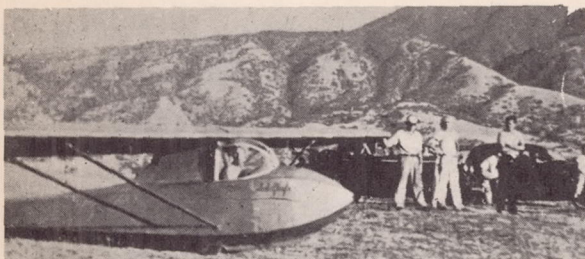
Figure 7.- Jensen utility glider
Solvflugen used for
group II of glider tow tests.

The second group of tests were made on a glider named "Solvfuglen" (Danish for Silver Bird), identification number 12718, shown in figures 7 and 8. It was designed, owned, and operated by Volmer Jensen of Los Angeles. It is a conventional, braced, high-wing monoplane somewhat similar in features to the Cadet or to the standard Franklin Glider. It belongs in the so-called Utility or Secondary class. Its wing span is 36 feet and wing area, 166 square feet. Its gross weight in towed flight was close to 450 pounds, comprising:

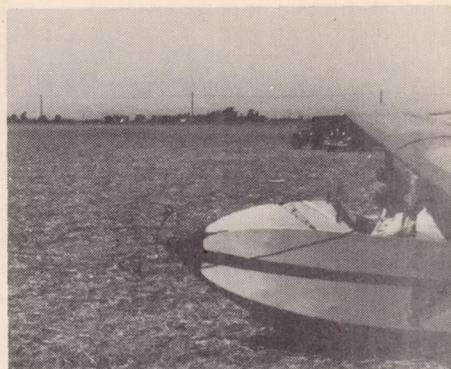
Figure 8.- Jensen utility
glider Solvflugen
used for group II of glider
tow tests showing the tow-
line release rope.

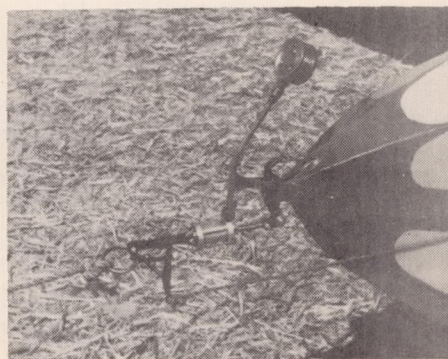
Figure 10.- Tensiometer in-
stallation for
group II of glider tow tests.
